# FACILITY COMPLIANCE INSPECTION REPORT

## Division of Waste Management Solid Waste Section

**Date of Site Inspection:** May 14, 2013

Bladen County Landfill, 1522 Mercer Mill Road, Elizabethtown, NC 28337

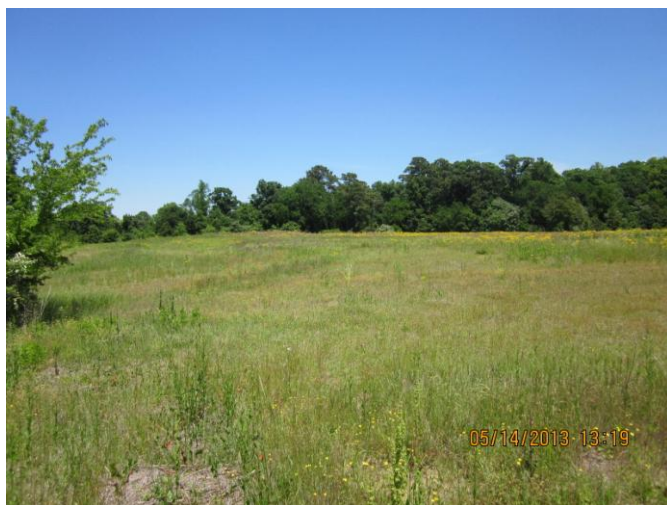
Cover on closed MSWLF.

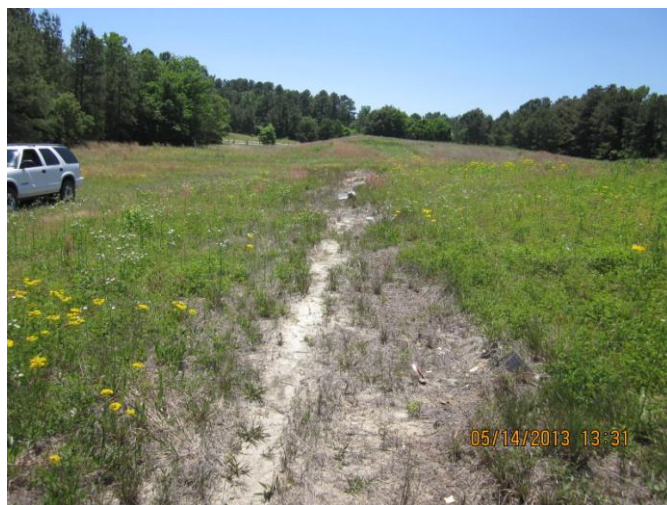
1. The facility is secured with a gate to prevent unauthorized access.
2. Semi-annual groundwater monitoring documents are on the CARA website.
3. An eroded area was observed on the eastern side of the closed landfill. The eroded area needs to be repaired and vegetative cover established.
4. The vegetation on the majority of the closed landfill was approximately 24 inches in height. County staff will contact me once mowing has been completed for a follow up inspection of the landfill and monitor wells.
5. Digital photos were taken during this audit.

Eroded area on east side of closed MSWLF.
